Bay 14:

OBG Seg 14W:

WELDING INSPECTION REPORT

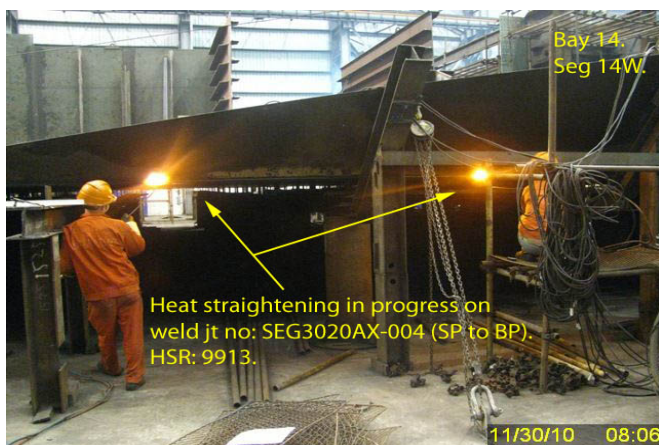
ZPMC personnel doing heat straightening of weld jt no: SEG3020AX-004 [Bottom Panel (BP) 3087A to Side Panel (SP) 3131A, complete joint penetration (CJP) weld]. Heat straightening was done as per heat straightening report (HSR): 9913 Rev-0. See attached photo for further details. ZPMC QC was identified as Qiu Wen.
